NISTIR 4724

Preliminary Study of the 1991 Oakland Hills Fire and Its Relevance to Wood-Frame, Multi-Family Building Construction

November 1991

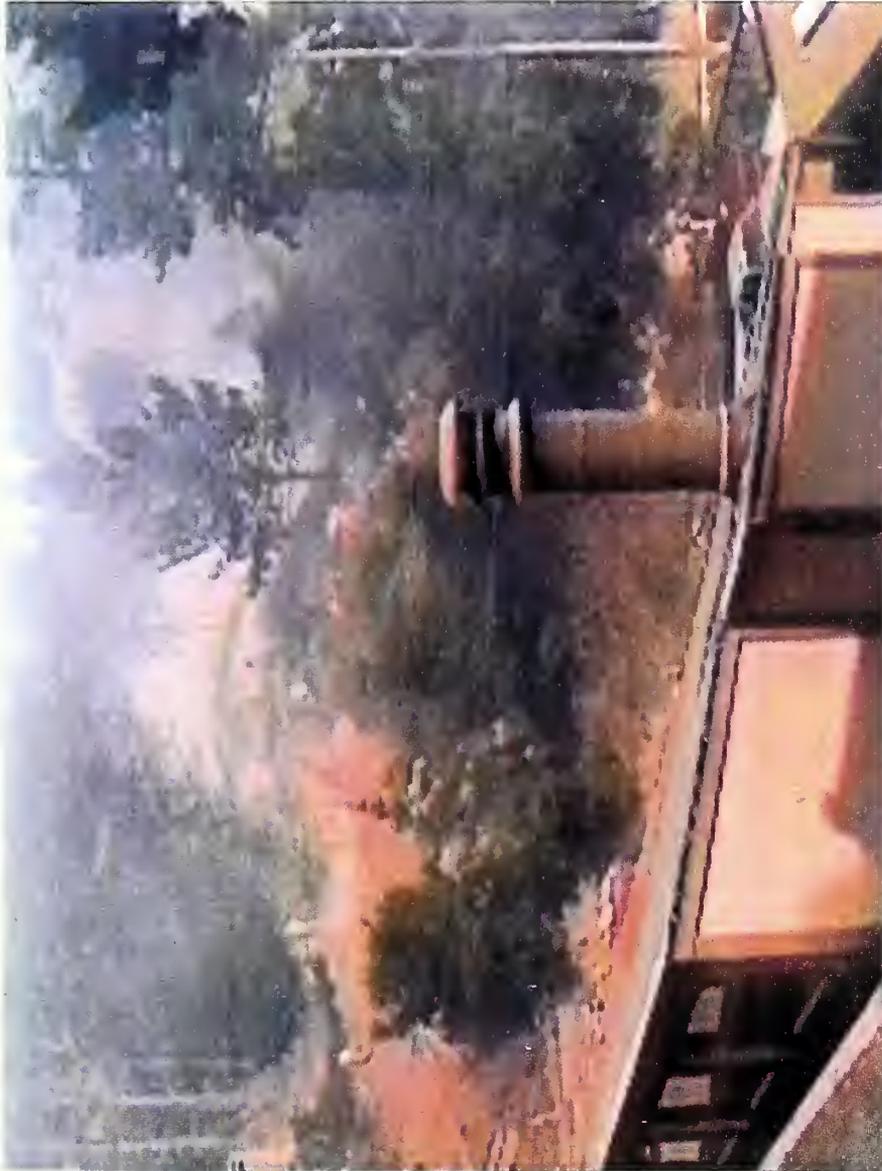
Figure 2. Fire rekindles on hill side between Buckingham Blvd. and Grizzly Peak Blvd. (Image courtesy of KTVU News, Oakland, California, broadcast October 20, 1991)

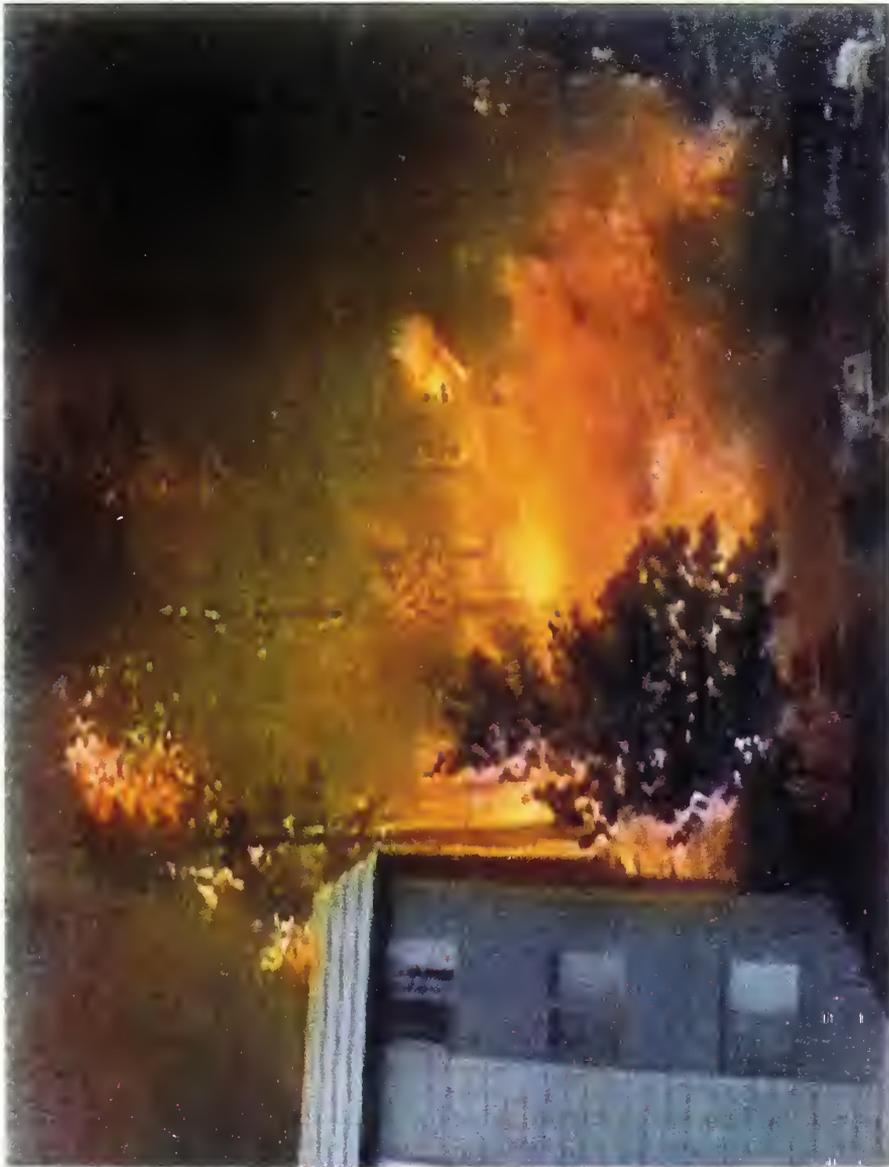
3. The wind shifted to the south at 1110 hours and the fire began spreading down the slope toward the Parkwoods Apartments located near the entrance to the Caldecott Tunnel. This hot, dry, locally erratic Santa-Ana type wind averaged about 9 m/s (20 mph) with gusts from 16 to 22 m/s (35 to 50 mph). At 1130 hours, $4 \times 10^5 \text{ m}^2$ (100 acres) were burning. The fire entered the area of the Parkwoods Apartments at about 1140 hours, see figure 3.

Figure 3. Fire from burning vegetation enters area of Parkwoods Apartments.
(Image courtesy of KTVU News, Oakland, California, broadcast October 20, 1991)

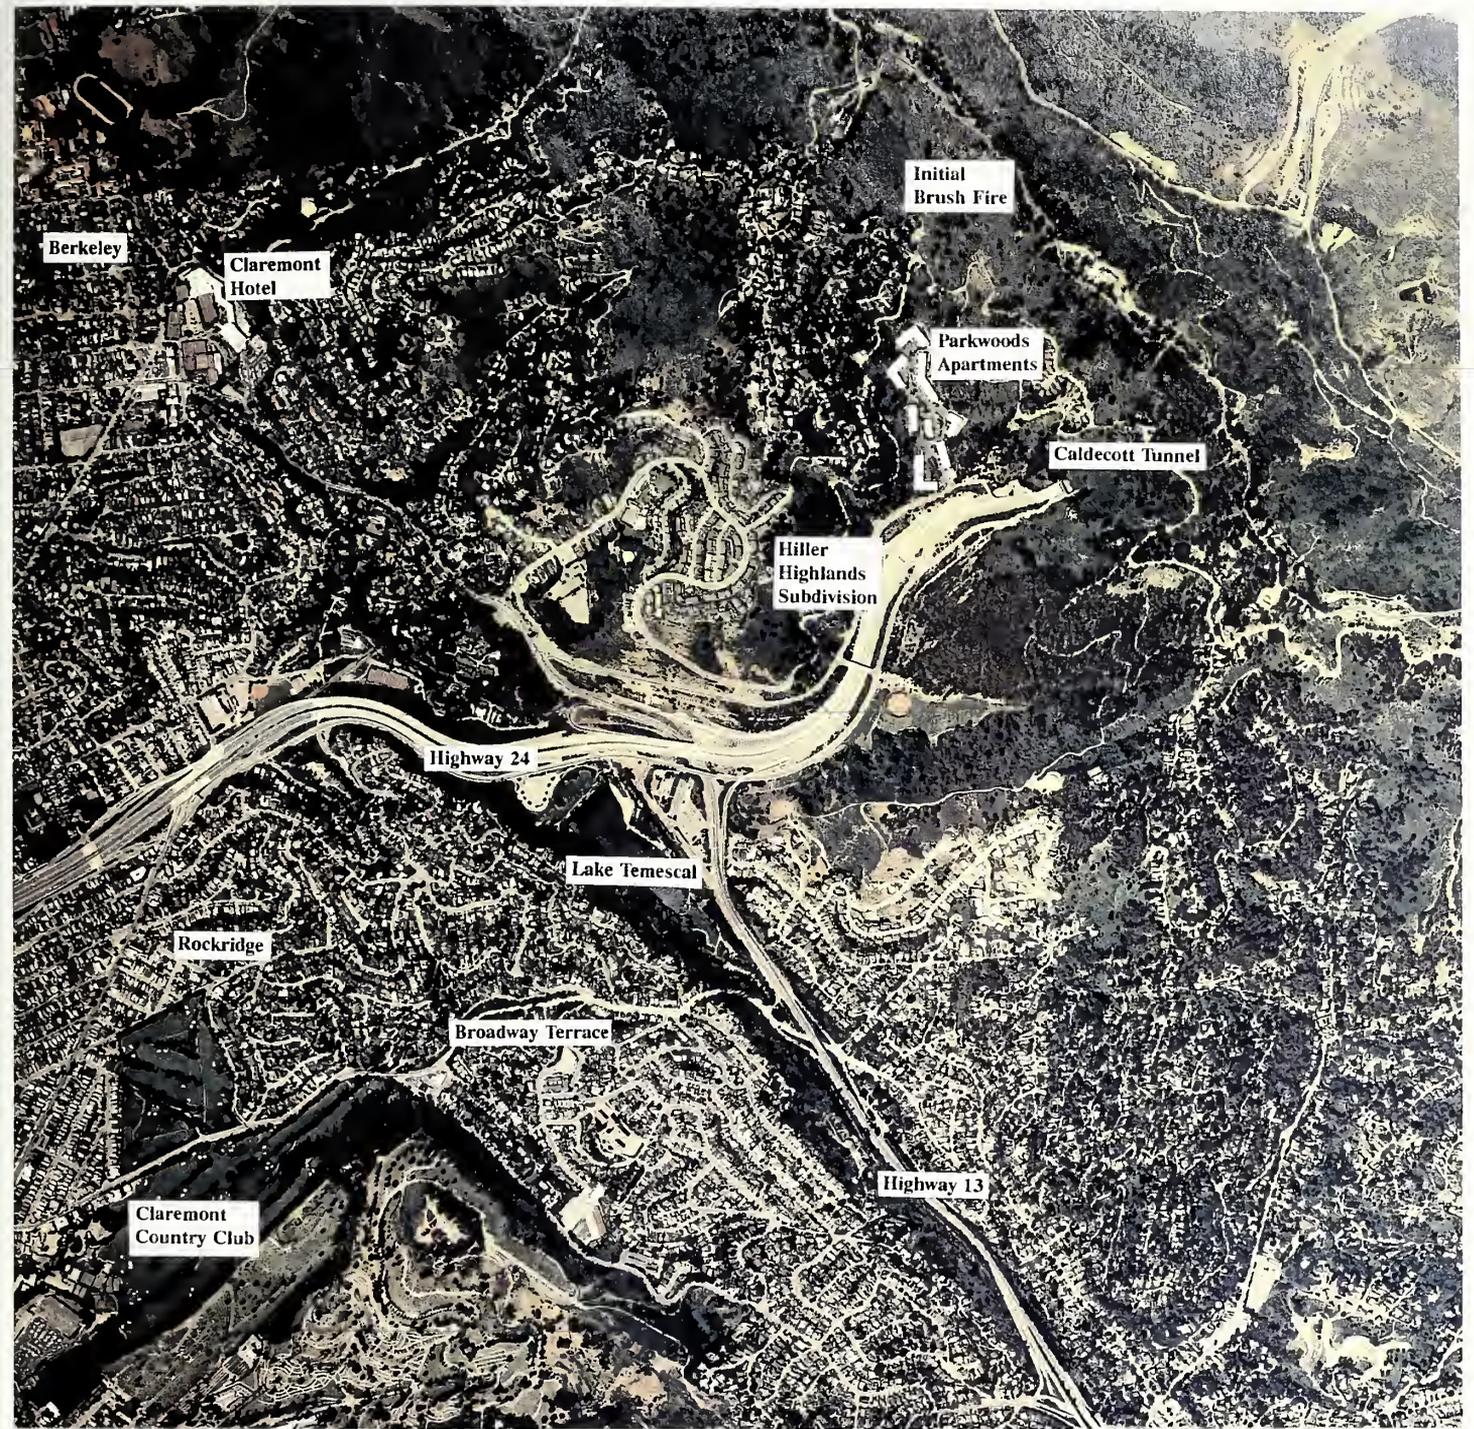
Figure 4 shows an aerial photograph of Oakland and Berkeley hills on April 30, 1990 about 18 months prior to the fire. Figure 5 shows the same area on October 23, 1991 after the conflagration. Virtually all of the structures within the large central area of the fire zone were destroyed. Along the perimeter of the fire zone there are totally destroyed, partially damaged, and apparently untouched structures intermixed. It is believed that intervention by the fire department saved most of these "untouched" homes.

Figure 4. Aerial view of the Oakland and Berkeley hills on April 30, 1990. (Photograph from Pacific Aerial Surveys of Oakland, California)

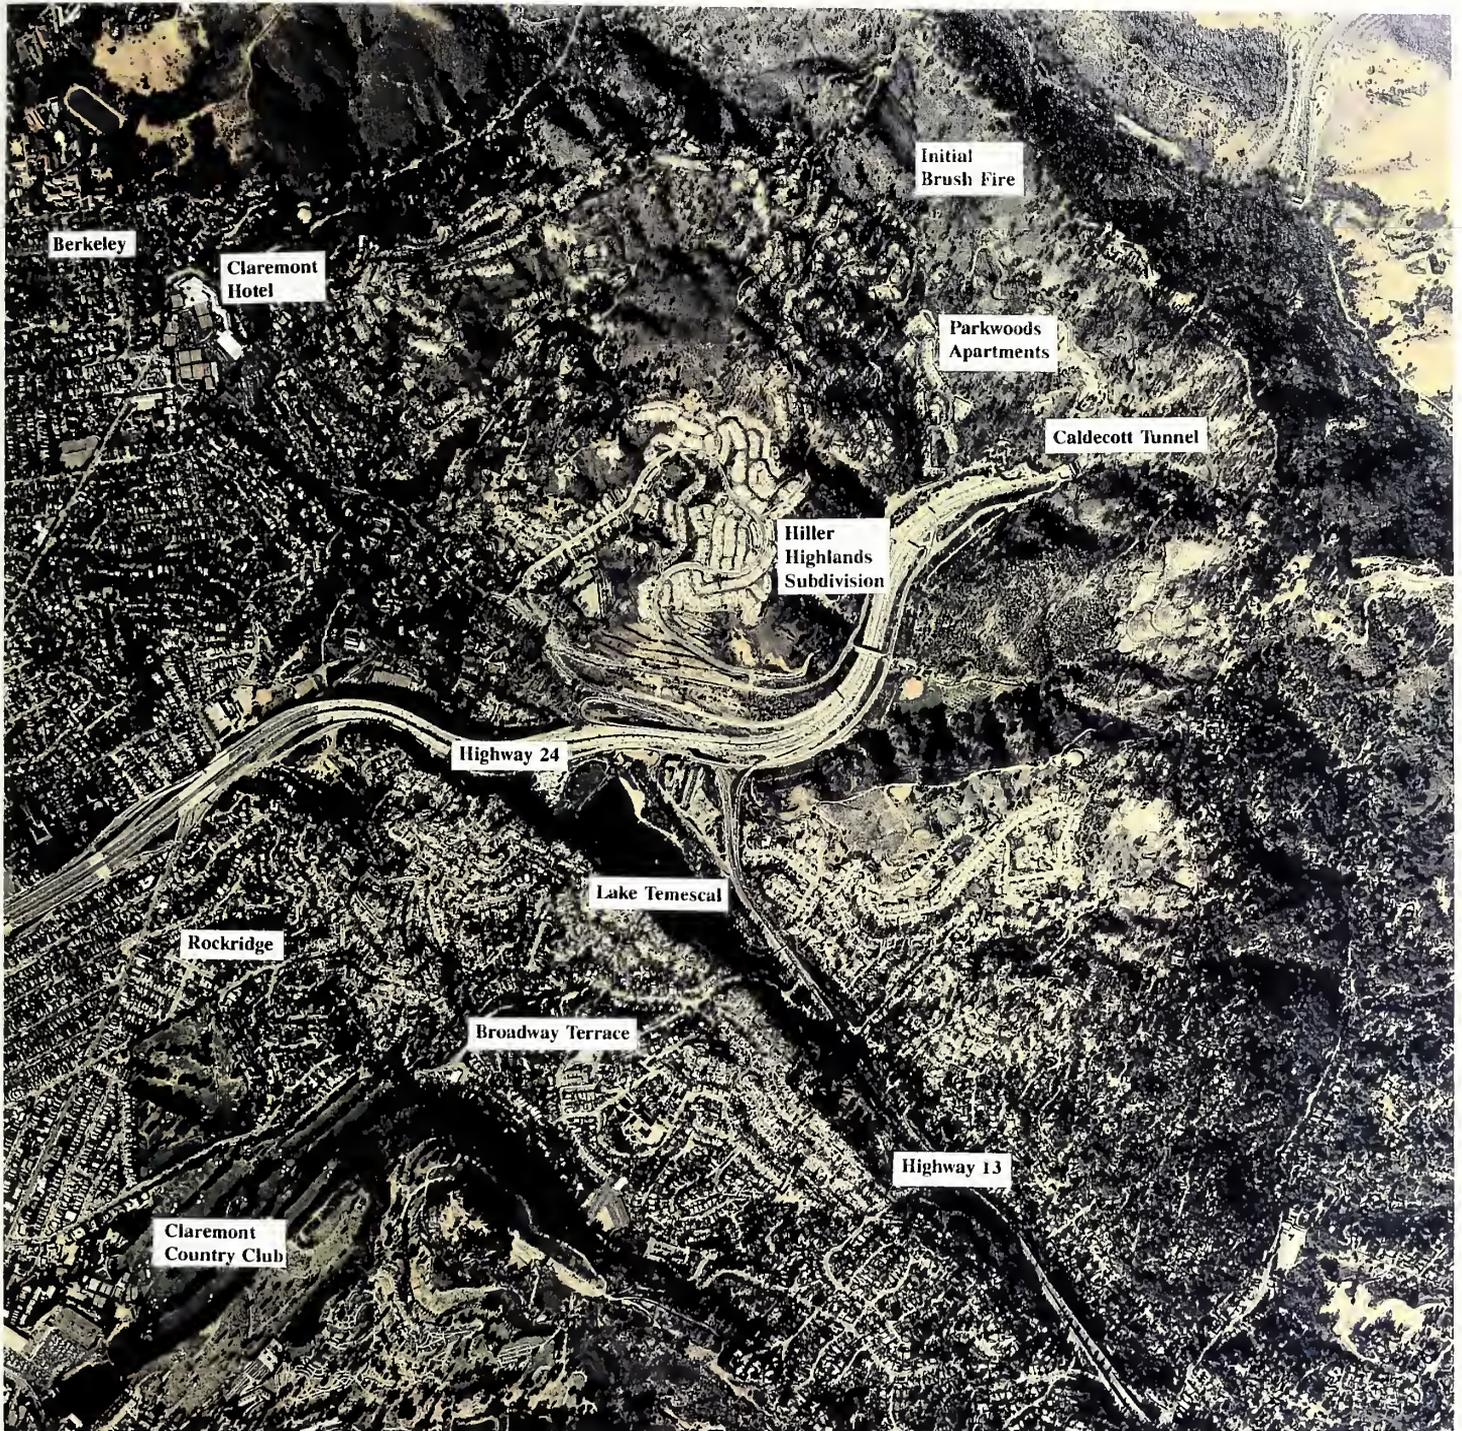
Figure 5. Aerial view of Oakland and Berkeley hills on October 23, 1991.
(Photograph from Pacific Aerial Surveys of Oakland, California)

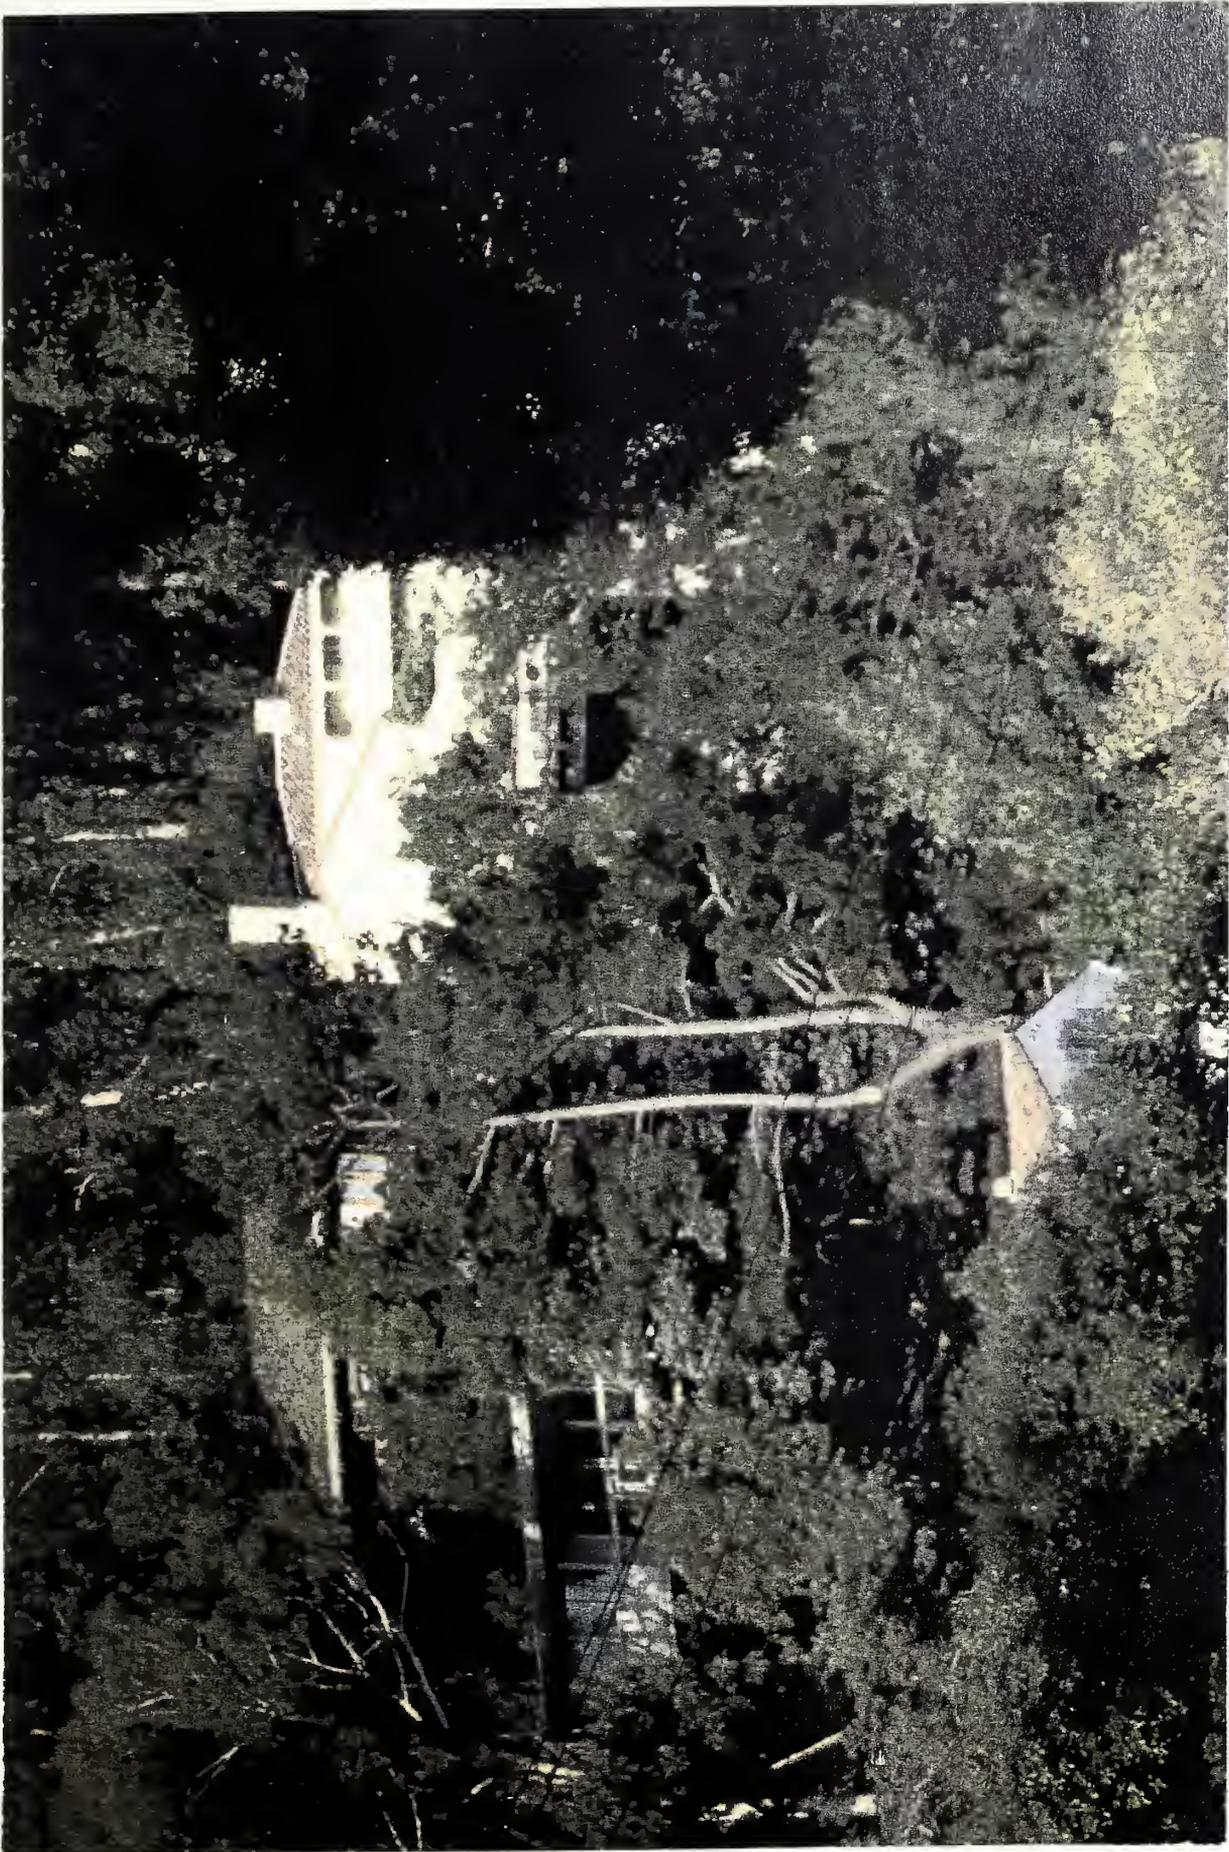
Figure 6. Homes built amid vegetation west of the Oakland hills fire area.

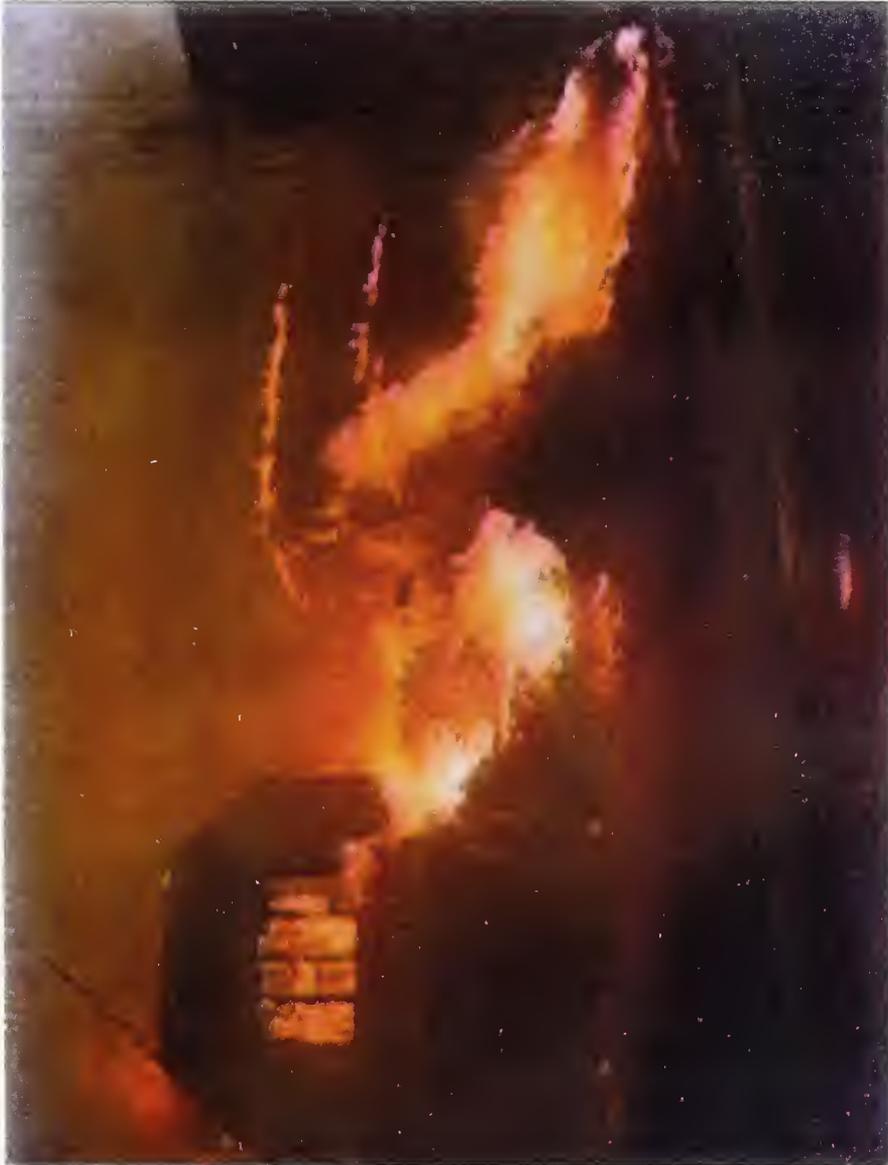
Figure 8. Winds fan burning of homes and adjacent vegetation during the Oakland hills fire. (Image courtesy of KTVU News, Oakland, California, broadcast October 20, 1991)

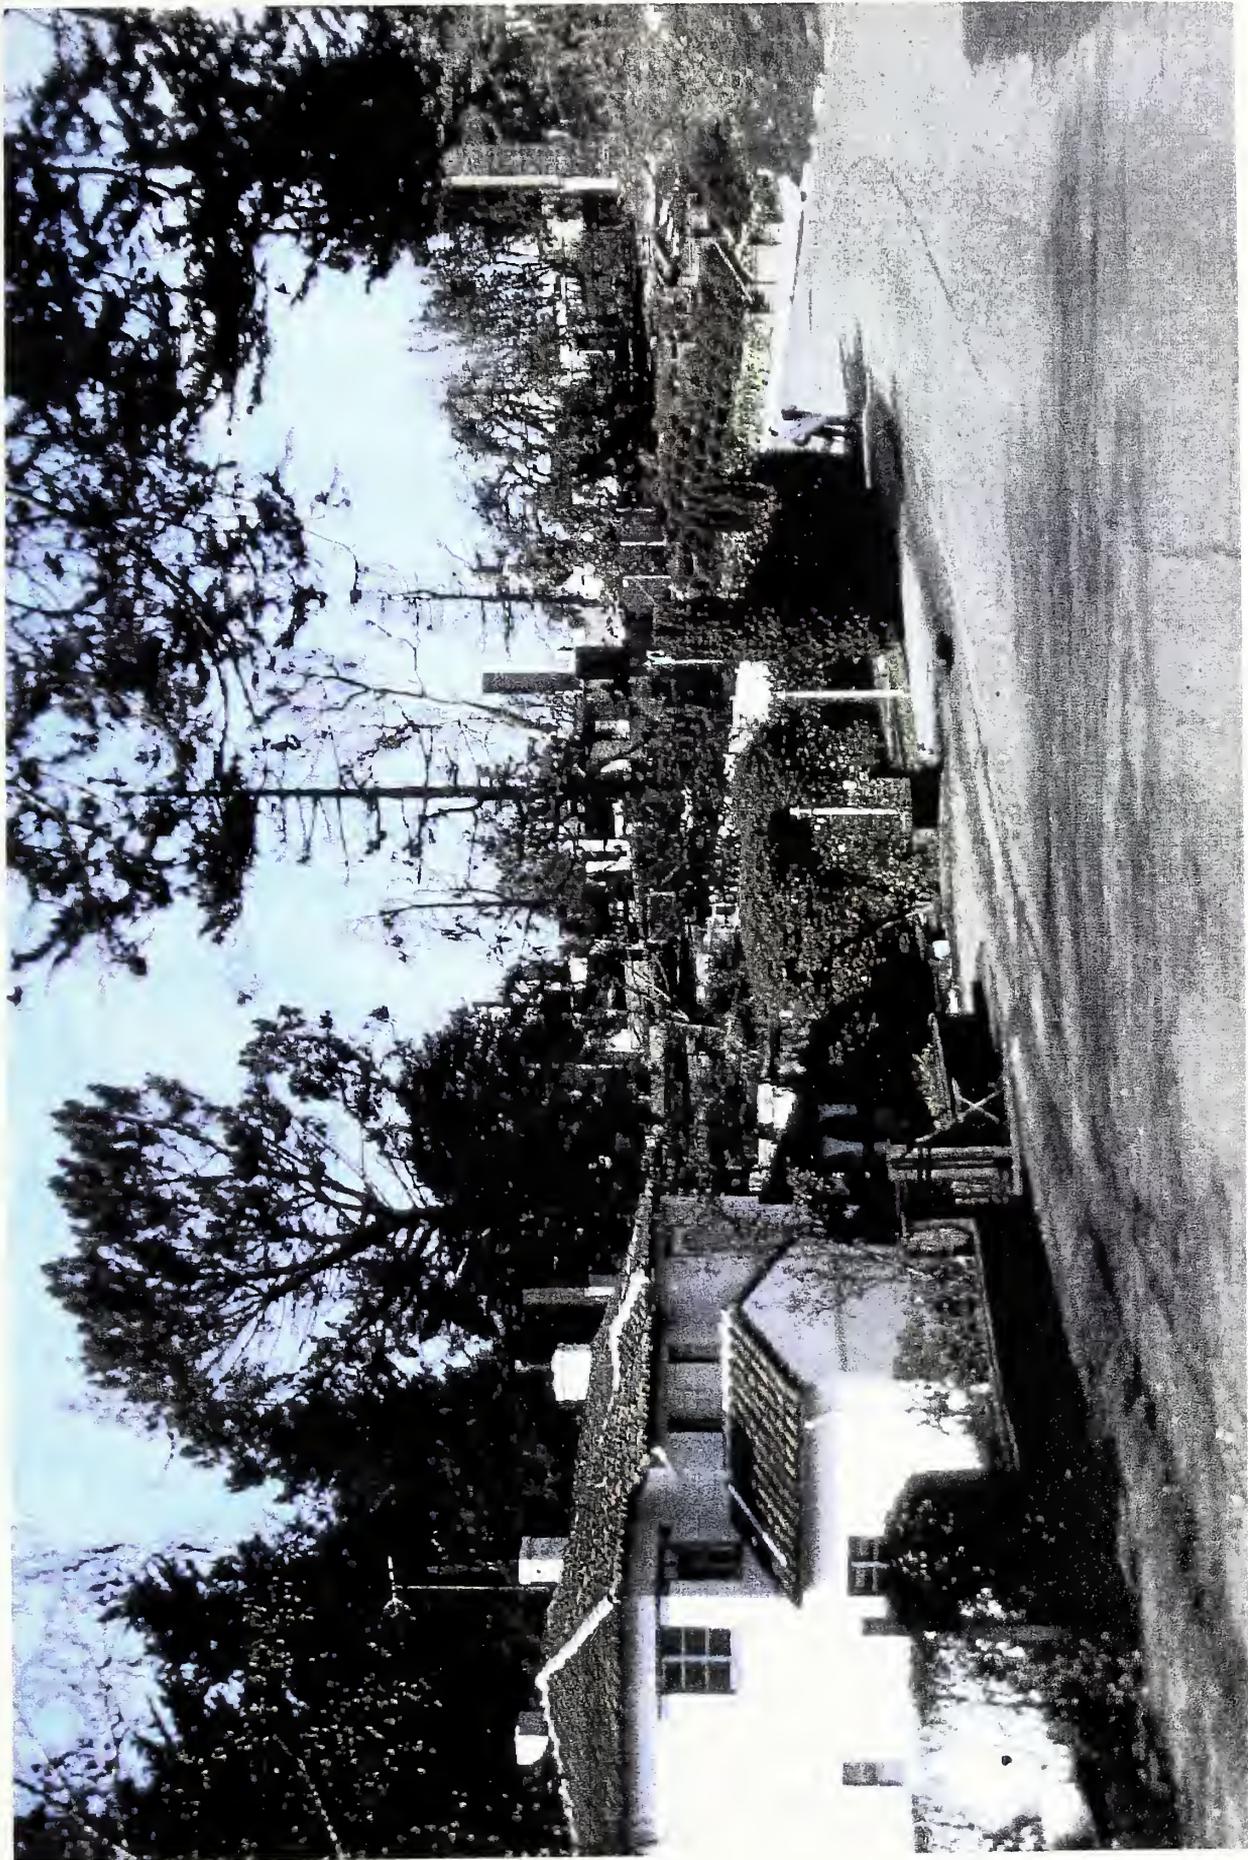
Figure 9. Damage along Beechwood Drive near Glenbrook Drive (just south of Acacia Avenue in figure 1) at the periphery of the fire zone north of Mountain View Cemetery.

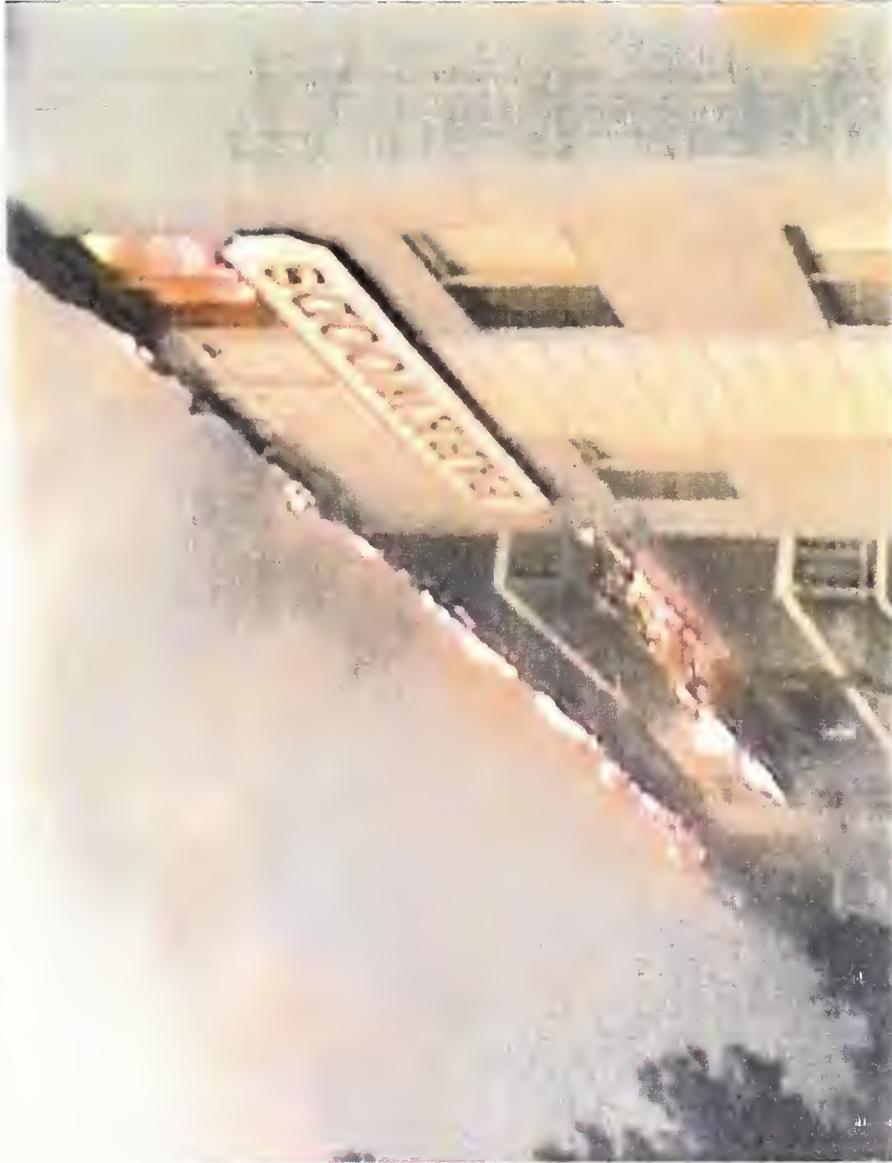
Figure 11. Burning roof and third floor apartment during Oakland hills fire. (Image courtesy of KTVU News, Oakland, California, broadcast October 20, 1991)

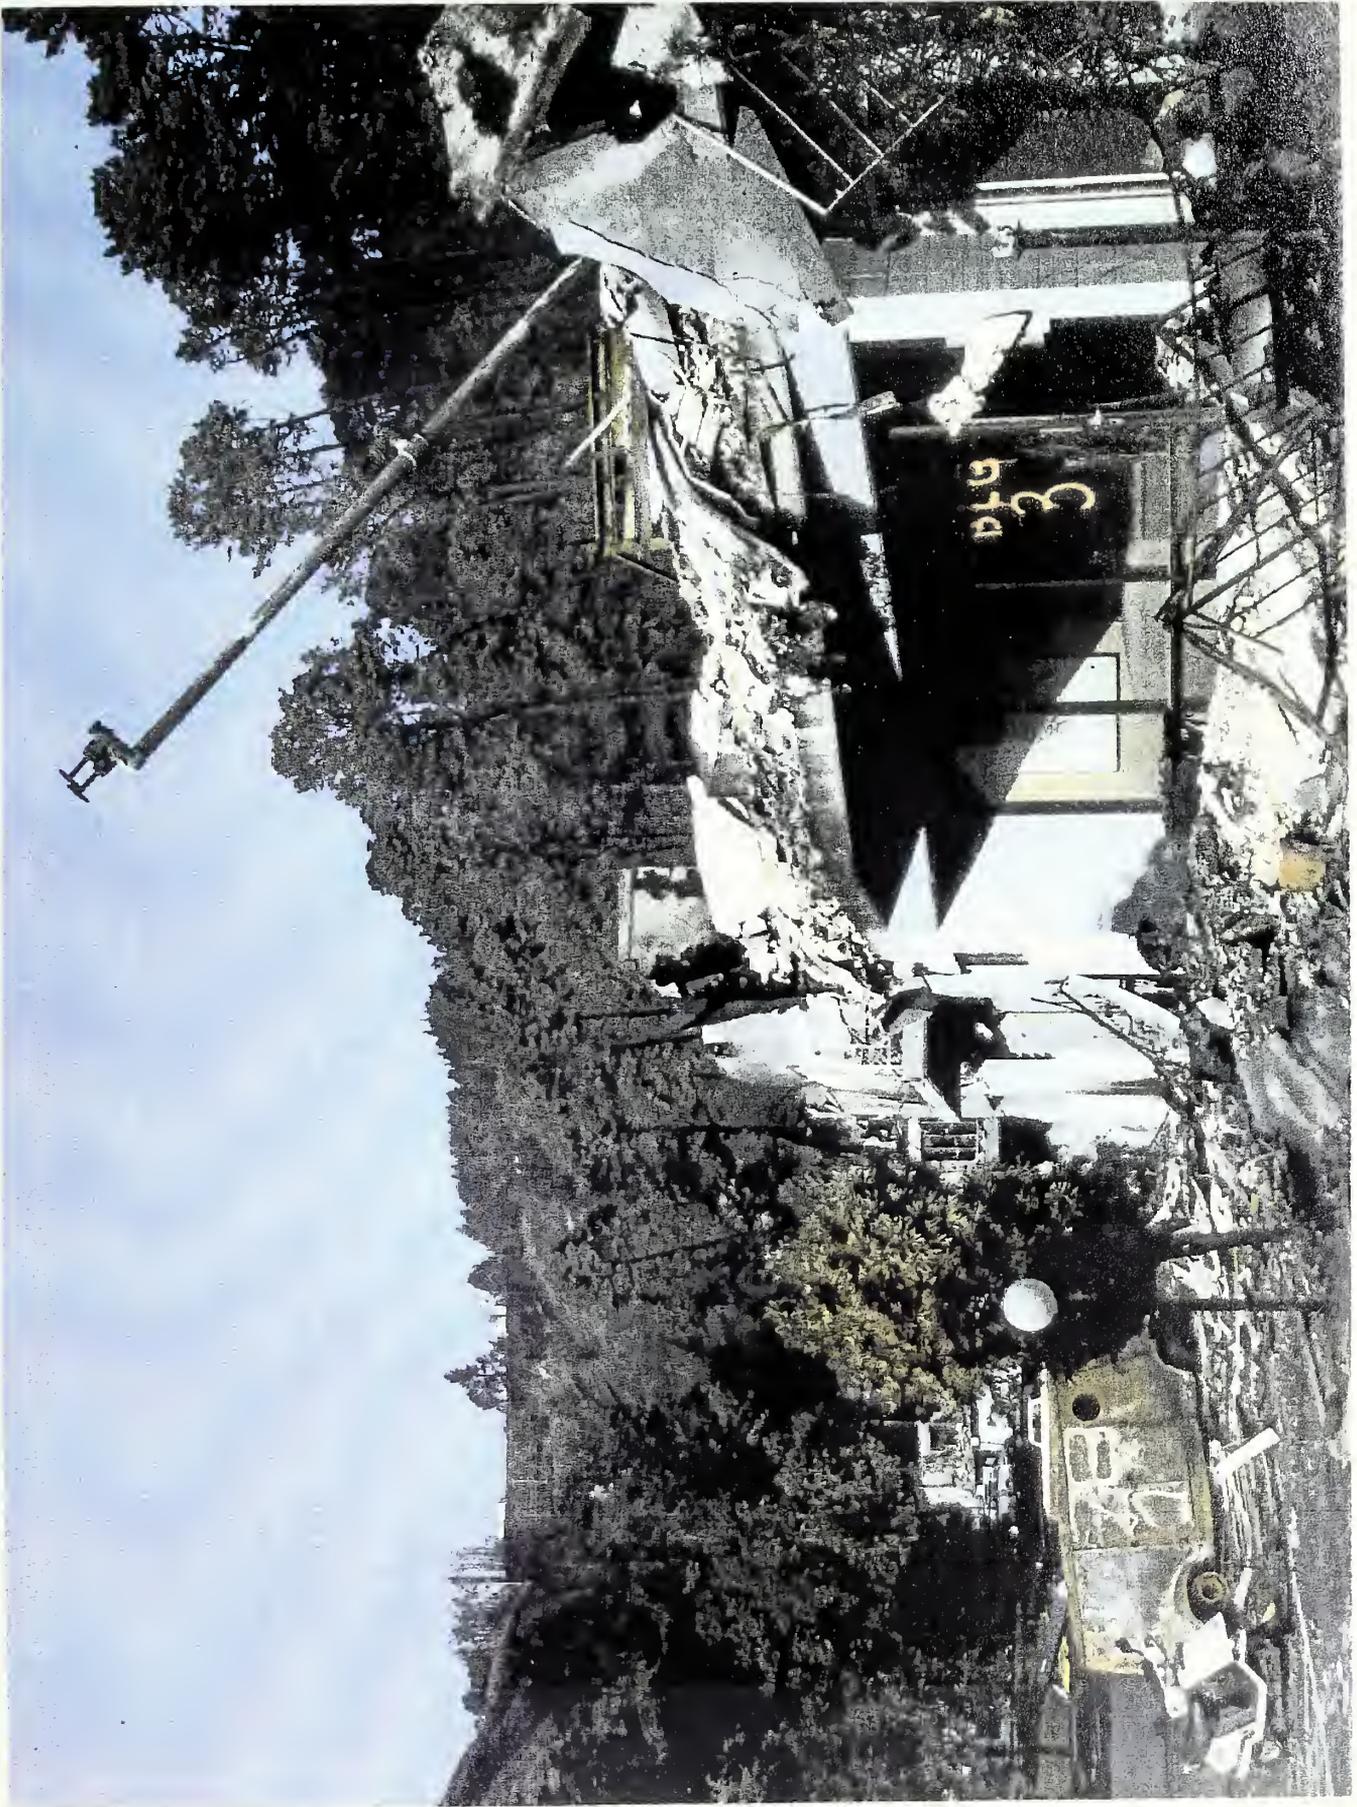
Figure 12. Remains of one of the buildings in the Parkwoods Apartments after the Oakland hills fire.

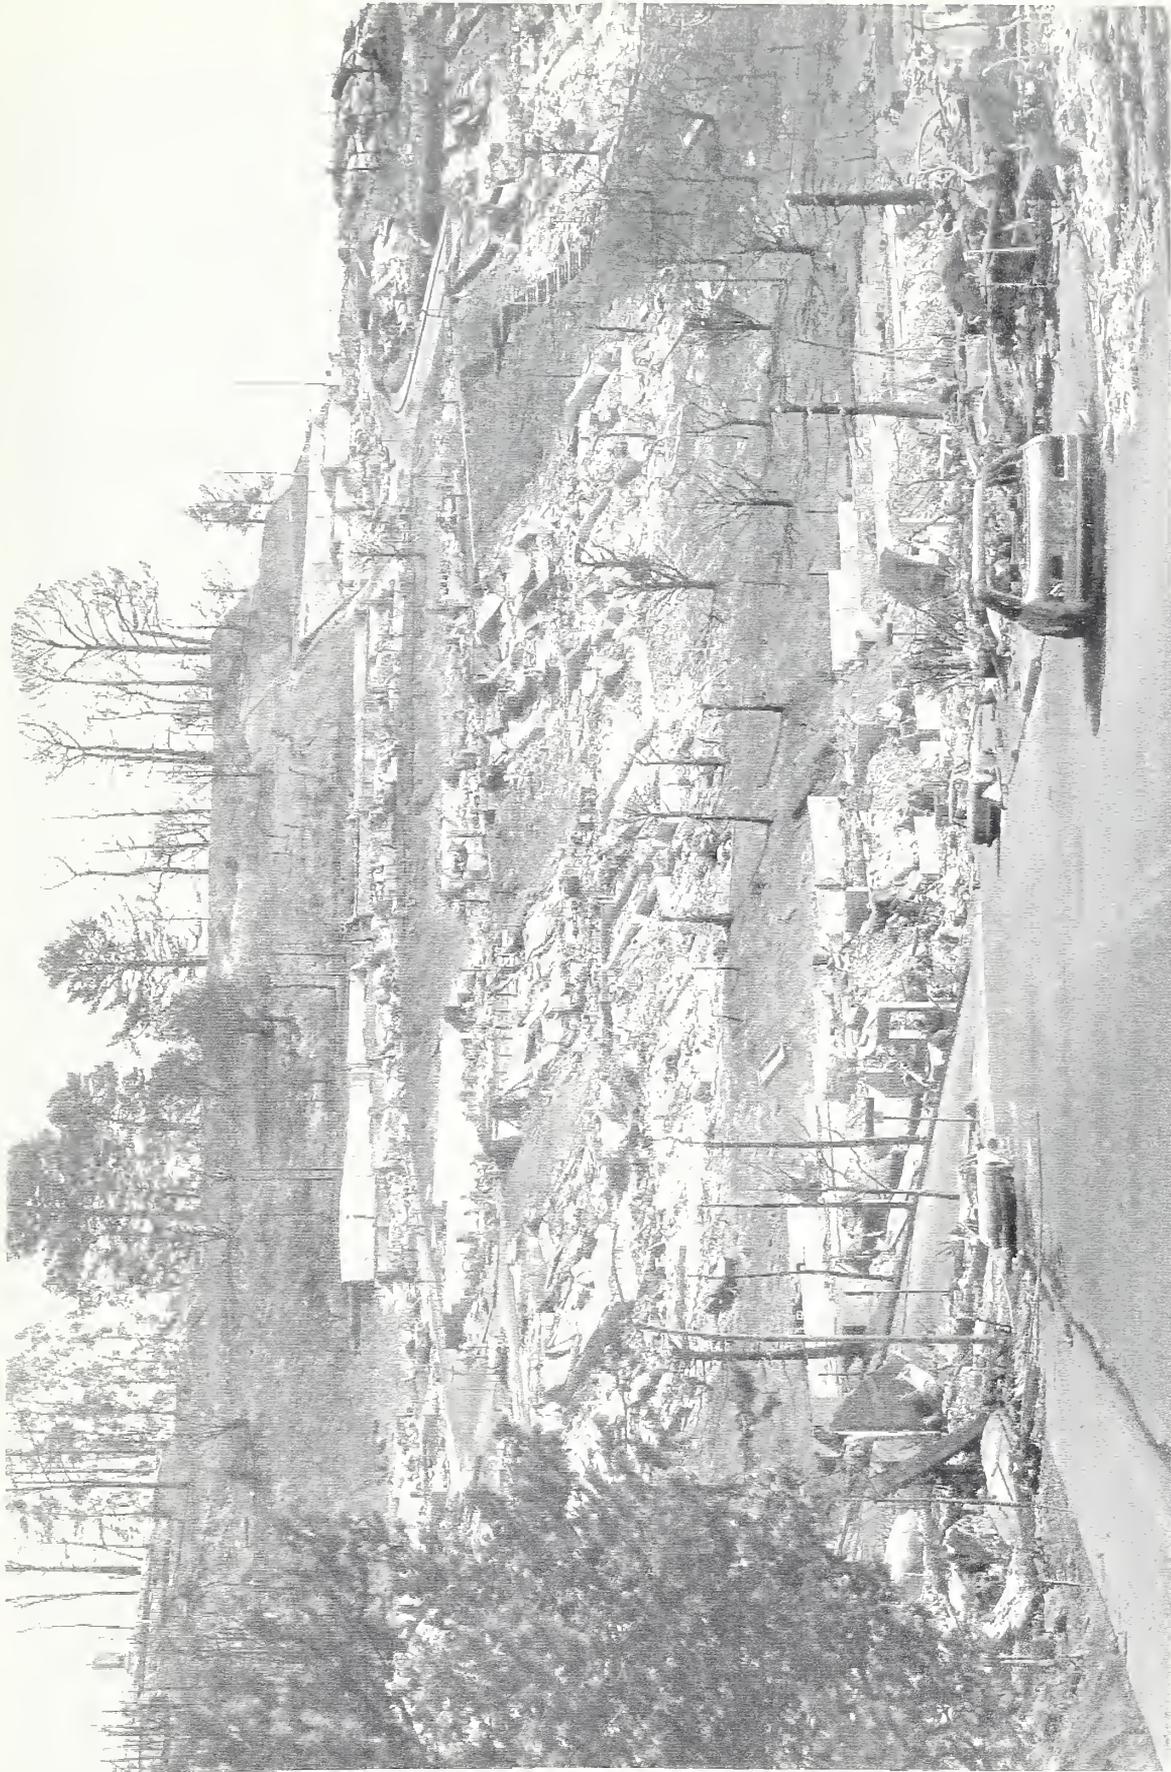
The fire began in an area that was on the edge of the developed land on the west side of Grizzly Peak Boulevard. Housing in that area is relatively sparse, compared to the high density attached housing found in the Hiller Highlands subdivision. Figure 13 shows a section of the Hiller Highlands subdivision before the fire. Dwellings are closely spaced or attached to one another. Often vegetation is found throughout the open areas and in some cases in contact with the buildings. The fire approached the development from the other side of the hill shown in the picture (figure 13). The fire moved through the community in less than one hour, reducing the development to the rubble and ashes seen in figures 14 and 15. The burning of this housing development was not

Figure 14. Section of the Hiller Highlands subdivision (also shown in figure 13) after the Oakland hills fire. (Photograph by Michael Macor, published in the Oakland Tribune, October 27, 1991).

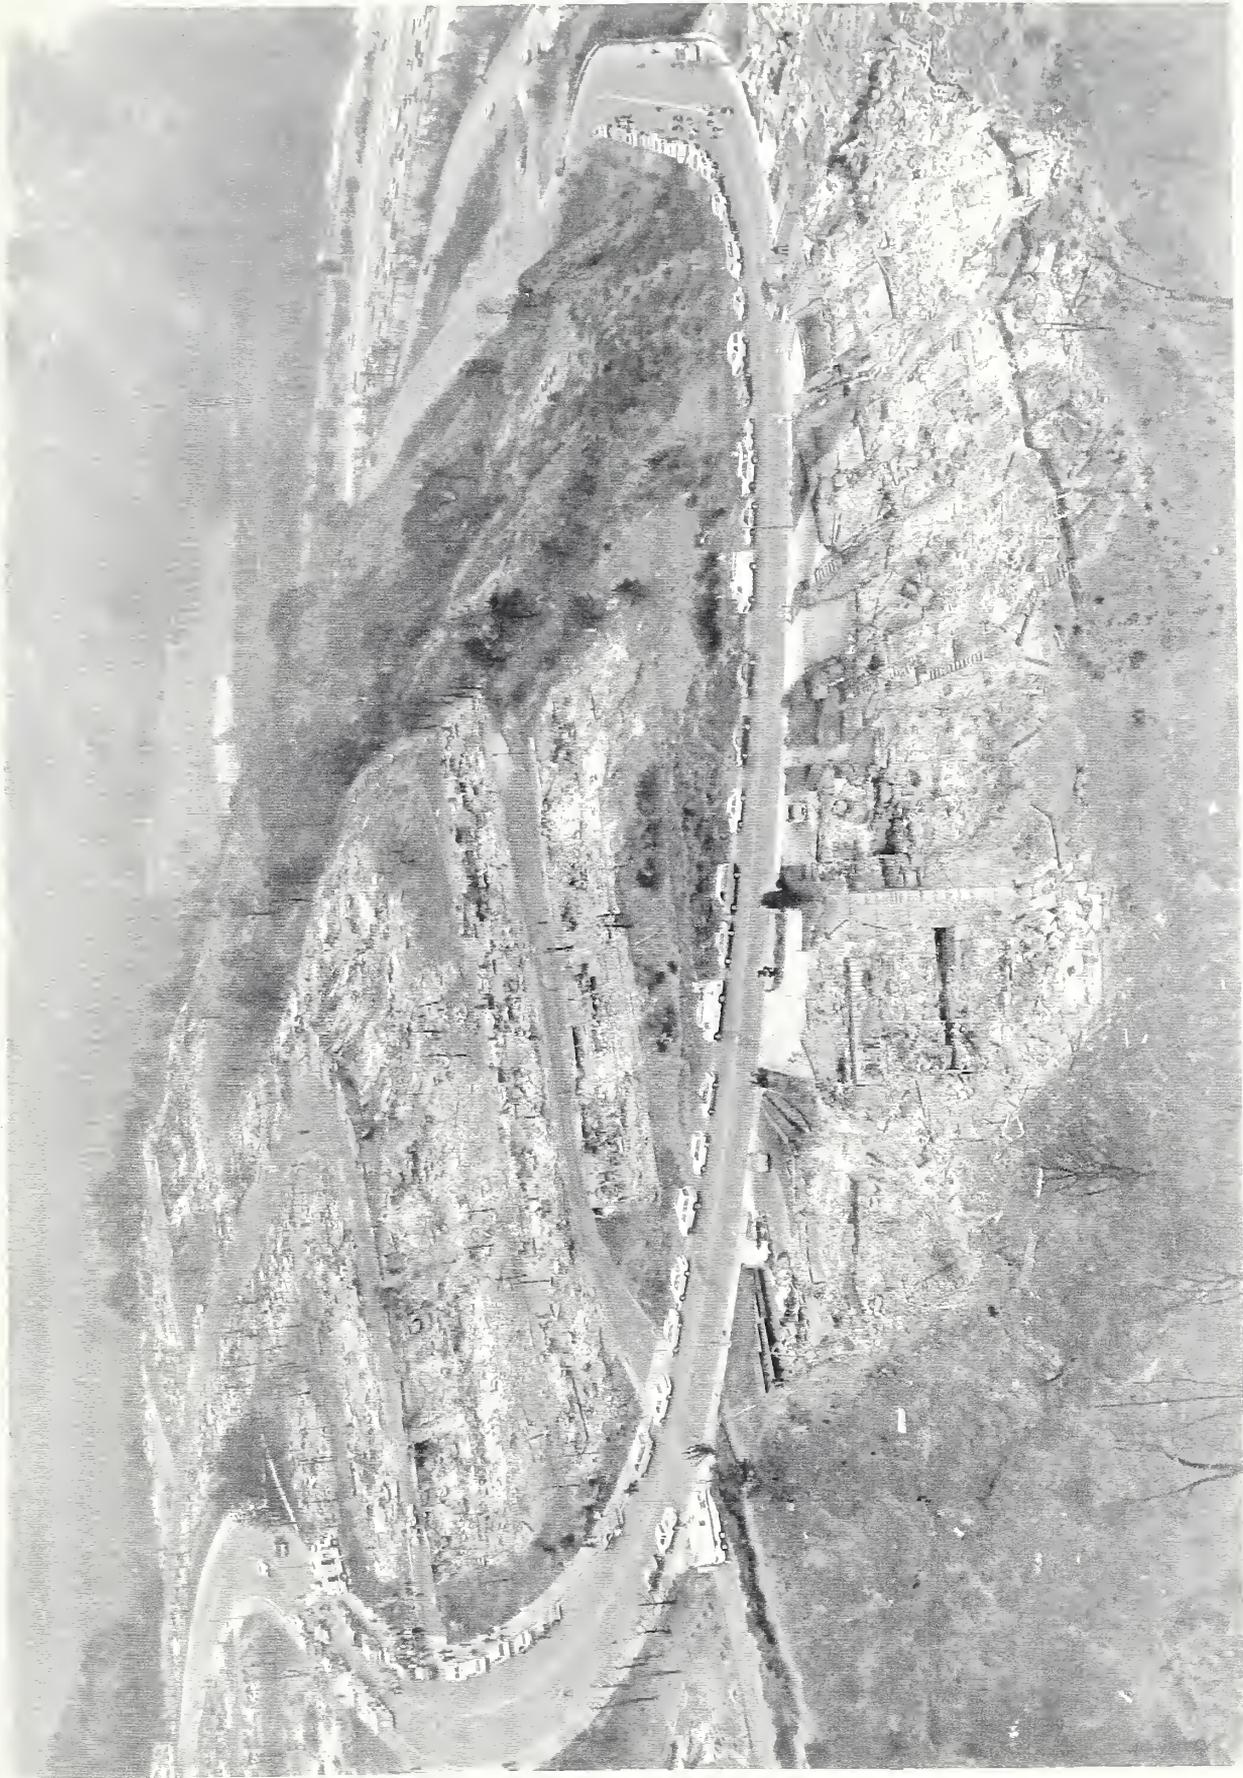
Figure 15. Aerial view of Hiller Highlands subdivision after the Oakland hills fire. State Highway 24 which the fire spotted across is seen in the upper right. (Photograph by Gary Reyes, published in the Oakland Tribune, October 23, 1991).
